## The production line

### 2004 (04 programme):

## Body, suspension, brakes and wheels

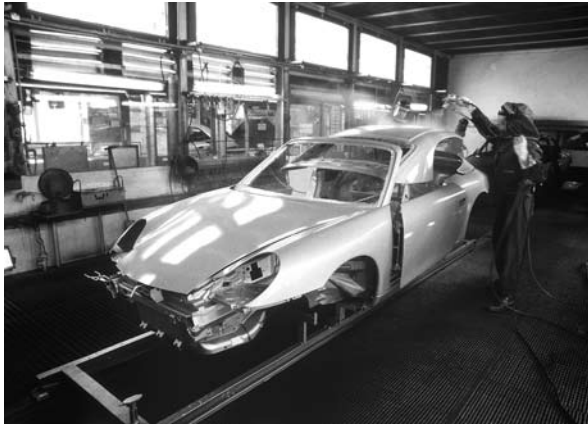
A 996 Cabriolet being hand-painted just like all the previous series. Notice the hardtop being painted at the same time, which ensures a perfect match.  
Contributor: Dr. Ing. h. c. F. Porsche AG

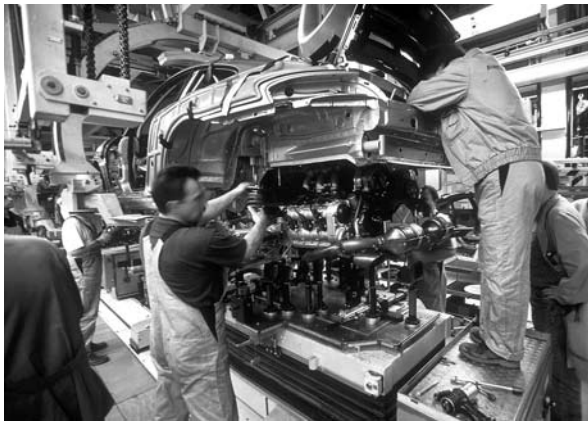
The 996 production line with lots of hands on deck, and not a robot to be seen anywhere. Looks hand-assembled, just like the 964 and 993.  
Contributor: Dr. Ing. h. c. F. Porsche AG

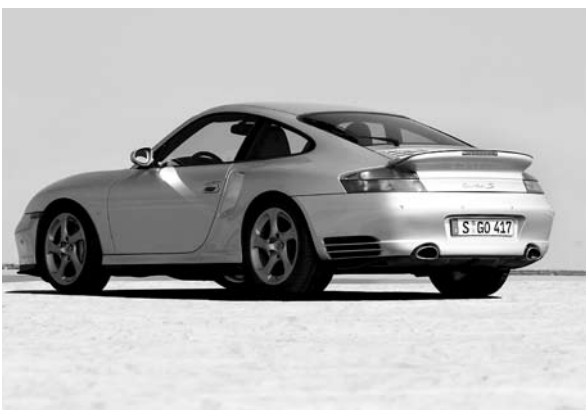
Externally 996 Turbo S models could be identified by their yellow brake callipers and Turbo S badge on the engine lid.  
Contributor: Dr. Ing. h. c. F. Porsche AG

PCCB was offered as standard with yellow 6-pot (piston) brake callipers on the front and yellow 4-pot (piston) brake callipers at the rear.

The ceramic brake discs (rotors) were increased in diameter to 350mm (13.8in) at the front and rear, but the thickness of the ceramic brake discs (rotors) at 34mm (1.34in) and 28 mm (1.1in) front and rear respectively remained the same as the steel versions.

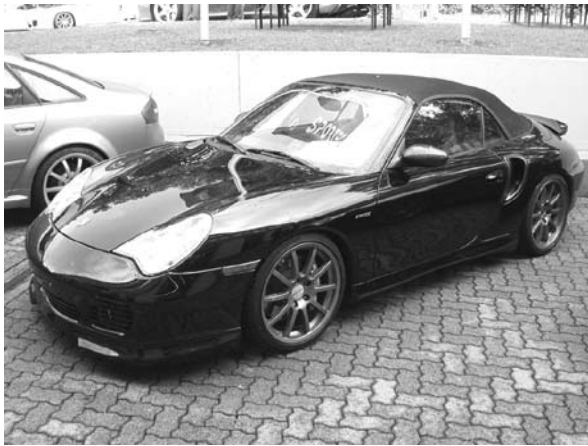
- ➡ Sportec aerodynamic enhancements for the 996 Turbo Cabriolet.

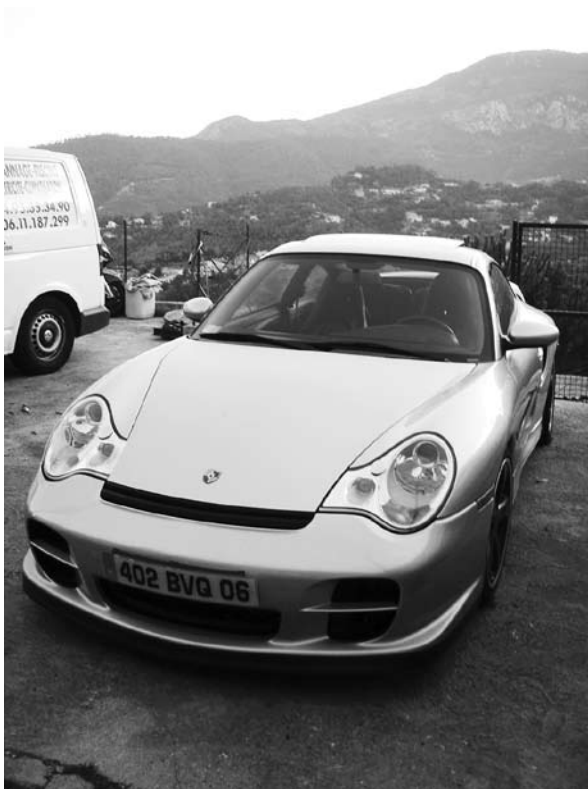
- ➡ TechArt aerodynamic enhancements to a 996 Turbo Coupé.
