## ENTHUSIAST'S RESTORATION MANUAL SERIES

# Chapter 4

## TR2-3A body restoration

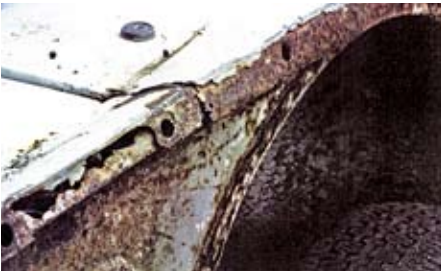
2-27. The rear deck on this car will not have looked too bad at first glance since the body filler (seen here sideways on) will have covered much corrosion. In fact the true extent of the problem will only have been revealed by looking at these panels from the inside of the boot/trunk or when the wing/fender was removed.

- Any external bubbling on the rear deck panel and forward deck section will signal trouble in the near future. Note that top repairs can be effected quite professionally, as photograph 2-27 shows, and hide, for a short while, the true seriousness of the situation – which is why an examination from inside the boot is particularly valuable. Feel where the rear wing is bolted to deck sections alongside the fuel tank. There will be cars where you will see daylight here because the panel has completely rusted away.

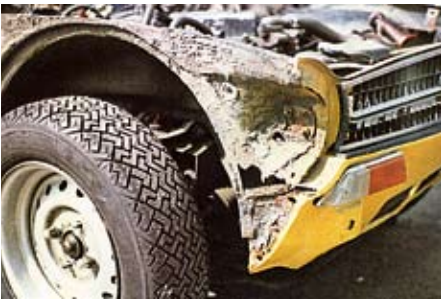
2-28. Although this is, of course, a TR6, it does demonstrate the care with which any potential purchase should be examined. This TR6 looked great from the outside but, a peak at the bonnet hinge area from within the engine compartment revealed the impending expense!

- Above and around the headlamps – the corrosion works back to the inner wings where the bonnet hinges mount, so look there too (from inside the engine bay). You will see an example of what to look for in photograph 2-28.

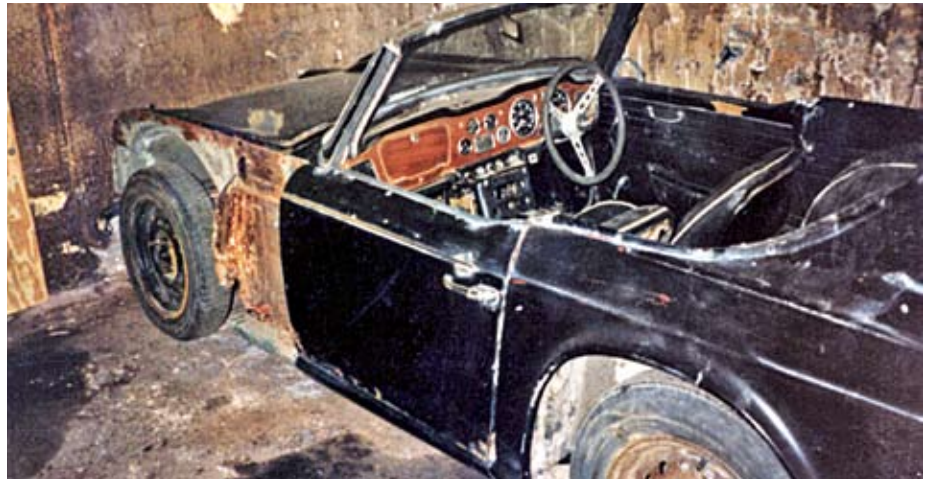
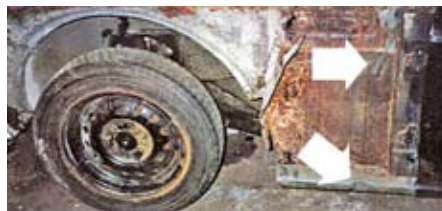
2-29 (above) and 2-30. Not as smart-looking, this TR4 had a rusting door, but you would never have thought that the rear baffle behind the front wheel would be completely rusted away. This would have been obvious, though, from a look from within the engine compartment. This is not untypical of what you must expect when you remove the front wings. Devoid of a worthwhile amount of original paint, the splash plate has rotted away at the top, allowing corrosion to attack and hole the top inner wing. Note, too, the bottom inner wing is also corroded and holed. This car has still got its original sills as you can see the indentation (arrowed) pressed in the sill to allow water to escape from the original plenum chamber's drain hose, also arrowed. Less obvious, this picture also demonstrates the typical upturn that occurs with years of use at both rear corners of the bonnet. It is a good idea to reinforce the inner lip of the bonnet for about 12in (300mm) in front of both rear corners to stop it kinking in future. A special repair panel is available.

- Baffles behind front wheels. The corrosion often manifests itself by the fuse-box on the inner wing and can be seen from inside the engine bay, although the real problem may be obvious from a very quick look under the front wings. The baffle can almost completely rot away, as photographs 2-29 and 2-30 show.

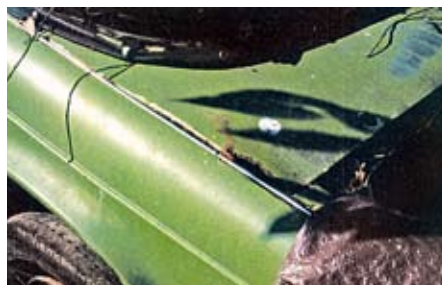
2-31. This picture demonstrates the extra vulnerability of the pre-TR6 cars. The stainless strip looks very attractive, but the reaction between dissimilar metals undoubtedly accelerates corrosion.

- As photographs 2-31, 2-32 and 2-33 illustrate, the TR4 and 4A wing-to-body joints

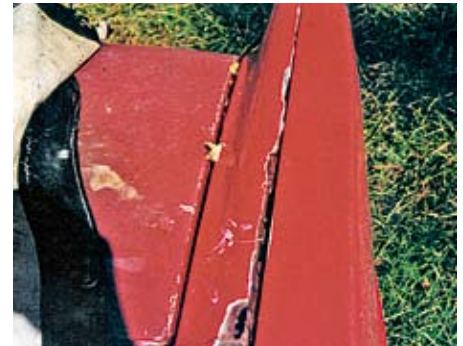
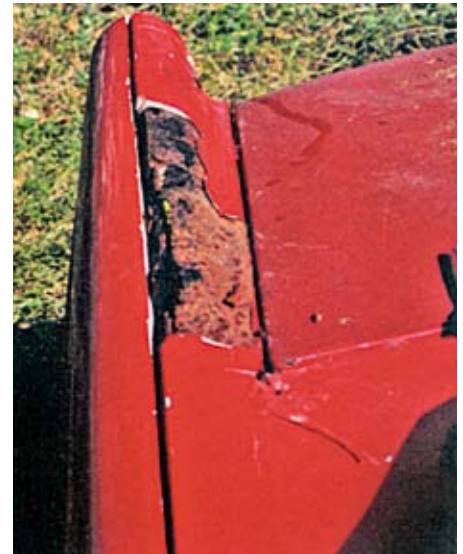
2-32.

2-32 and 2-33 (above). The first photograph might seem to be a duplication of 2-31, but in fact serves to emphasise the 'body filler' problem. Although this looks bad, picture 2-33 shows the full extent of the corrosion with a lump of filler removed. You could not have failed to see the extent of this corrosion had you looked from the boot/trunk side of these panels.

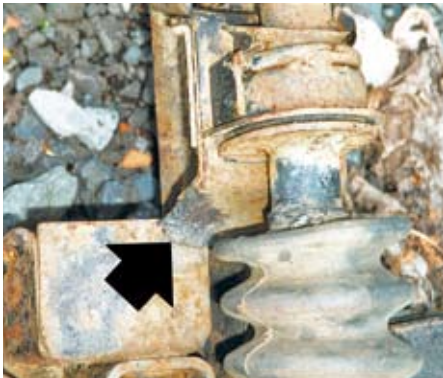
6-35-1. The TR4A steering rack (note the 'D' washers welded to the rack and the rubber cushion mounting), used, in fact, on TR4As, 5s, 250s and TR6s, with its traditional, but most undesirably cracked, mounting (arrowed).

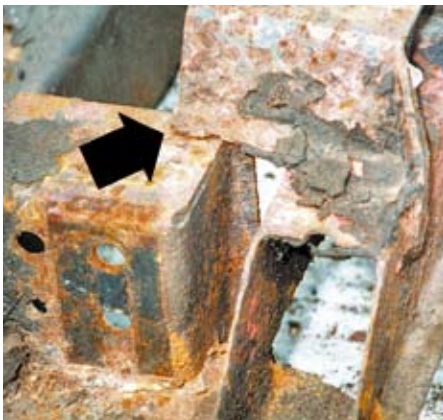
6-35-2. We see from a slightly different angle the front lower wishbone mounting bracket (in the centre), together with the steering rack mounting, this time without the steering rack in the way. The crack is arrowed and we can see the full area where a stiffening plate should be welded in.

6-36. All the premier TR restoration specialists will supply you with strengthening gusset kits. This is one quarter of Revington TR's front suspension kit (RTR7017), plus an example of their substantial lower wishbone attachment bracket. Note the pressed radii on the edges of the gussets which add considerable strength. This particular kit can be welded to the car with the body in situ.

two of 88155847, one of 88155531 and one of 88155532 – to quote the official Triumph part numbers (see photograph 6-36). All can be purchased from Revington TR, or indeed any premier TR restoration specialist, as strengthening kits with, you will note, pressed gussets for maximum rigidity.

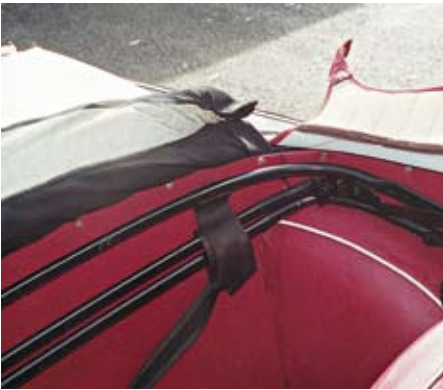
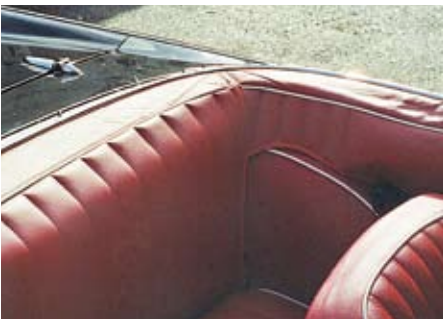
19-2.

19-2 and 19-3 (above). The TR4 hood frame is smaller, lighter and much less cumbersome than later TR frames. So much so, in fact, that it can be stored behind the rear seat back, as shown in the second picture. The extra time it takes to erect a TR4 hood partly arises from the need to roll the three rear seat trims (shown in the first photograph) out of the way, then to replace them once the hood frame has been erected. You may be able to see in the second picture that the peg just in front of the boot hinge is a fraction taller than those either side of it. This is for securing the rear hood webbing.

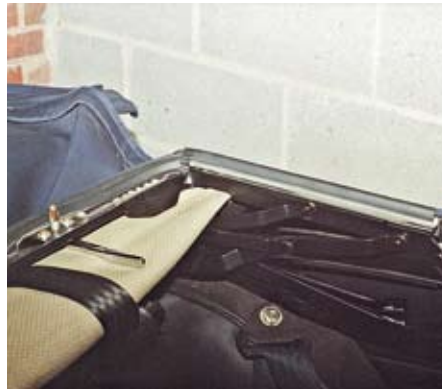
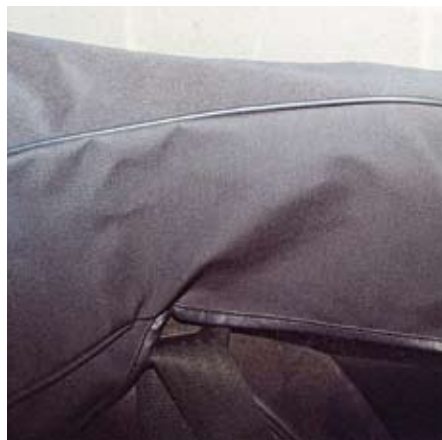
19-4.

19-4 and 19-5 (above). Comparative pictures of the post-TR4 hood frame/hood assembly. Picture 19-4 shows the hood frame without the hood cover, whilst 19-5 shows the hood cover in place. These shots are actually of a TR6, but, nevertheless, illustrate the differences in hood style and stowage of the later cars, compared to the TR4 shown in photographs 19-2 and 19-3.

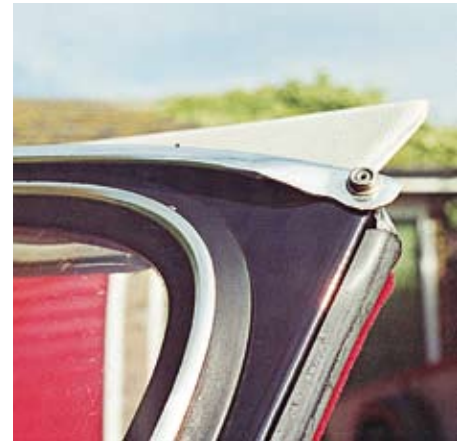
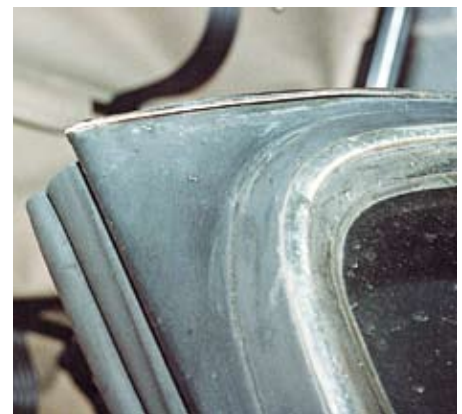
19-6.

19-6 and 19-7 (above). The first picture shows the earlier TR4 'lip' that runs right across the top of the windscreen to provide for the hood's front fastening. You can see the male press-stud that secures the end of the hood. The second shot shows the same location of the later car, and the now curtailed 'screen capping.'
