### WHEELS AND TYRES

#### SERIES 1 3.8 LITRE

#### FACTORY ORIGINAL - JAGUAR E-TYPE

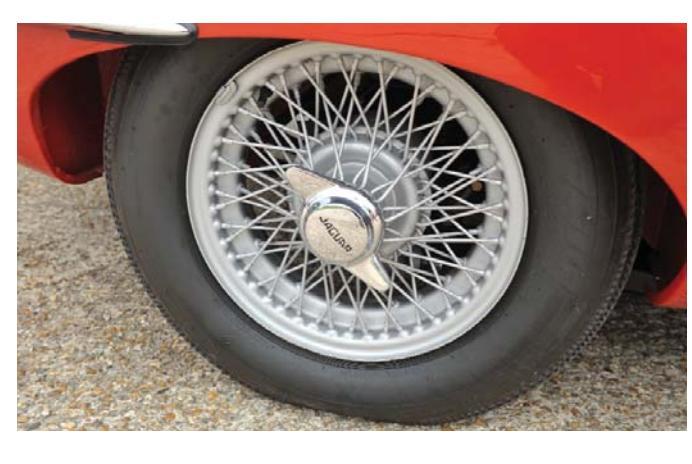
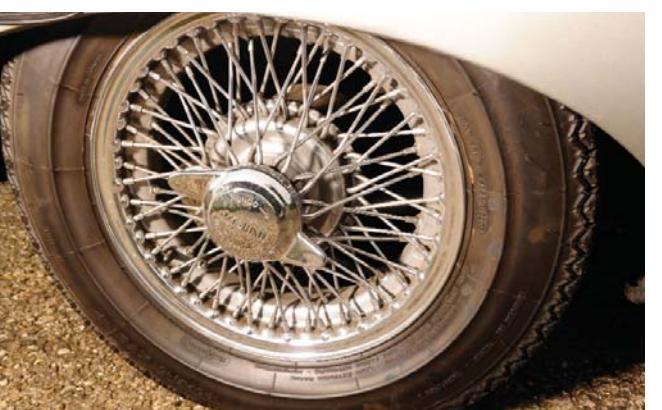
Basically the wire wheels were the same, but there were two different finishes as seen here – the red car has the wheels finished in stoved aluminium, while the silver car has the chrome wheels.

The wire wheels, size 5.00Kx15, had 72 spokes and were finished in stoved aluminium (silver), but chrome wire wheels were available as an option, and subsequently became standard on cars for the USA. "Platinum" finish wire wheels were quoted as an option. Wheels with 5.50 rims were available, for use at the rear only (Service Bulletin M.4). The centre hubs had a "dished" section. The eared hub caps bore the letters "JAGUAR" in a slight lozenge shape, an arrow in the "UNDO" direction and the words "LEFT (NEAR) SIDE" or "RIGHT (OFF) SIDE". Cars for Germany and possibly some other export markets had two rectangular tabs rather than ears, and these hub caps needed a special tool to remove them; they could be fitted on request to cars for other markets.

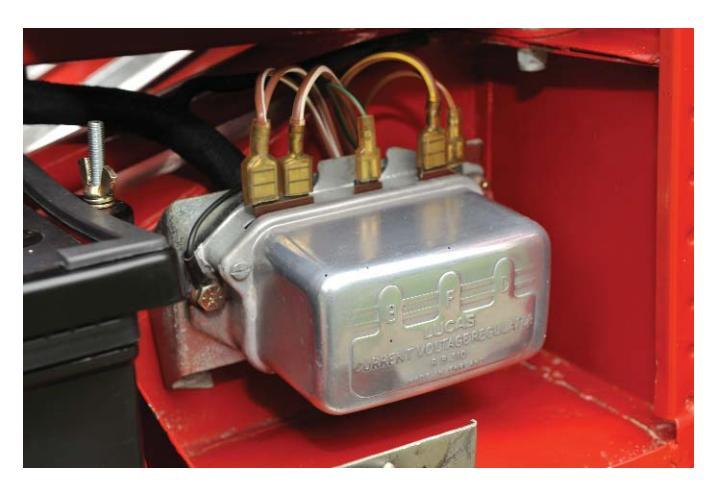
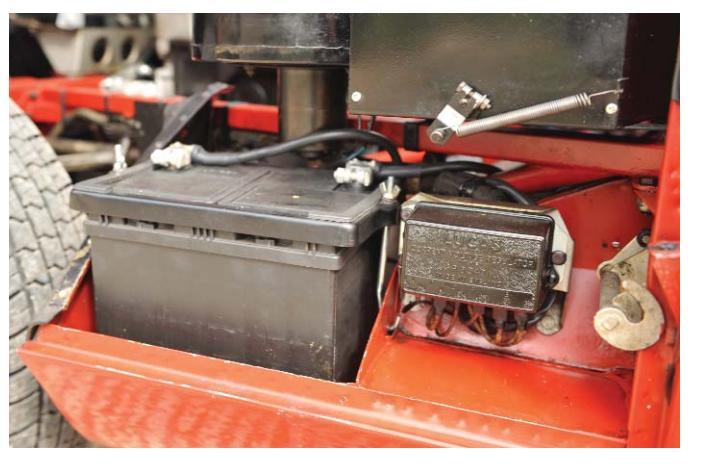
The battery and control box were mounted in the left-hand front sill, below the heater box. Early cars until August 1961 had the RB310 control box with an aluminium cover; later cars the RB340 box with a black plastic cover. Neither of the batteries shown is of the original type. Note also the two different types of bonnet lock catches, for the external and internal locks respectively.

Date	Change
5; 1	Aug 1961	Dynamo changed from C45 type to C42 type, new mounting bracket, voltage regulator changed from RB310 type with aluminium cover to RB340 with plastic cover; SPB A.56, Q.25, SB P.8
3; 6	Oct 1961	Two extra rubber corner pads fitted to ends of battery clamp; SPB Q.27
6; 1	Apr 1962	Modified horns with Lucar connectors; SPB Q.40
	May 1962	FHC: tail lights changed to fit modified body; SPB Q.43
3; 2	Jul 1962	Battery clamp rubber pads changed to single type; SPB Q.46
8; 5	Nov 1962	Modification to wiring harness for reversing lamp; SB P.18
4	Feb 1963	Change to headlamp flasher on cars for Italy, no longer operative when headlamps dipped; SB P.21
5	Sep 1963	Longer wiper blades fitted, except OTS RHD; SPB Q.74
7	Nov 1963	AF 700 sealed beam headlamps adopted on LHD cars for many export markets apart from the USA and Canada; SPB Q.91
0; 5	Mar 1964	Starter solenoid modified to prevent water entering; SPB Q.87

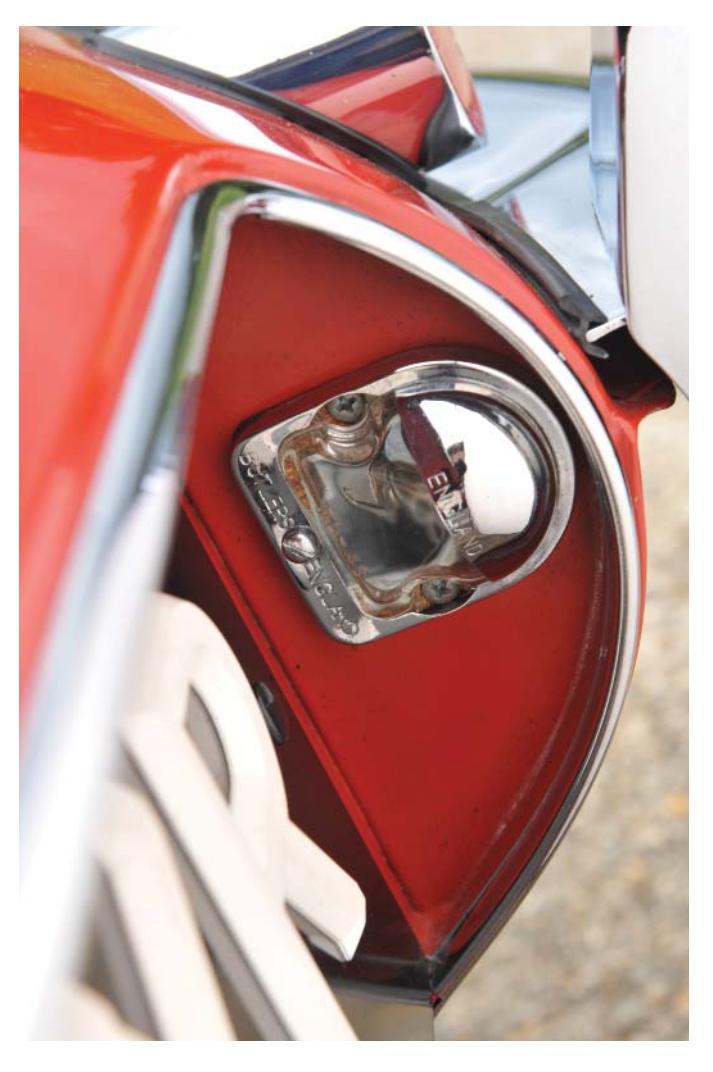
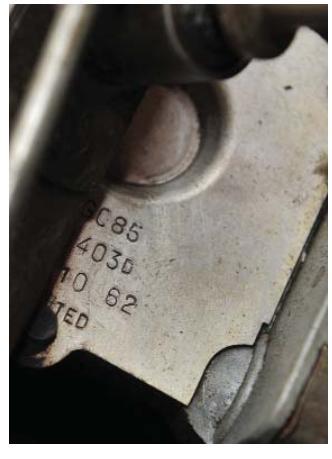
Some Lucas electrical components were date-stamped such as this wither motor "10 62", but also the dynamo and starter motor.

This is a Butler number plate lamp from the 1961 open two-seater; later cars mostly have Lucas units.

> The windscreen washer has a square-section glass bottle. To the left is the dipstick, with the handle marked "Stop engine - wait 1 minute", and between the two is the water valve for the heater.

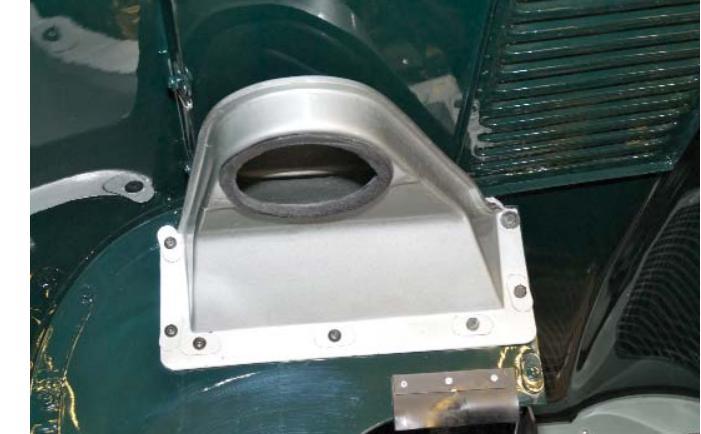
The heater air intake under the bonnet as used on the 3.8 and early 4.2 cars. On early cars it was silver, later mostly black.

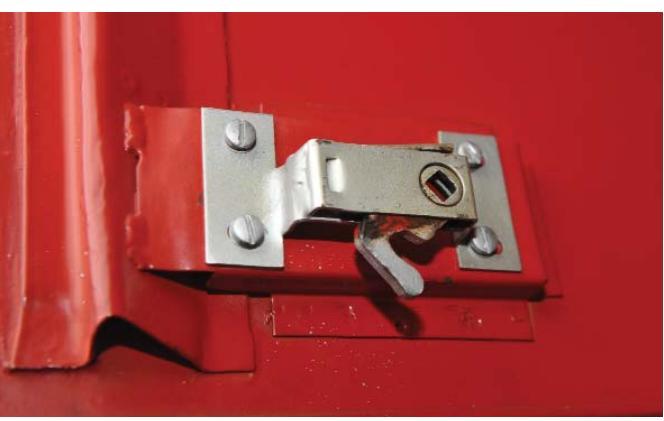
The external bonnet locks on the early cars had teardrop-shaped covers, pointing towards the rear, and were operated by a coach key. The third picture is the lock on the inside of the bonnet.
